Bradford Built International Harvester Major Brake Overhaul

While there are several descriptions around on how to change the brake disks on the Bradford built International Harvester tractors, a full restoration is a quite different and major task.

The following description is primarily for the later brakes as on this '67 B434 but applies equally to any tractor fitted with the later brakes. Operations on the earlier brakes are very similar and subsequent notes will highlight any differences.

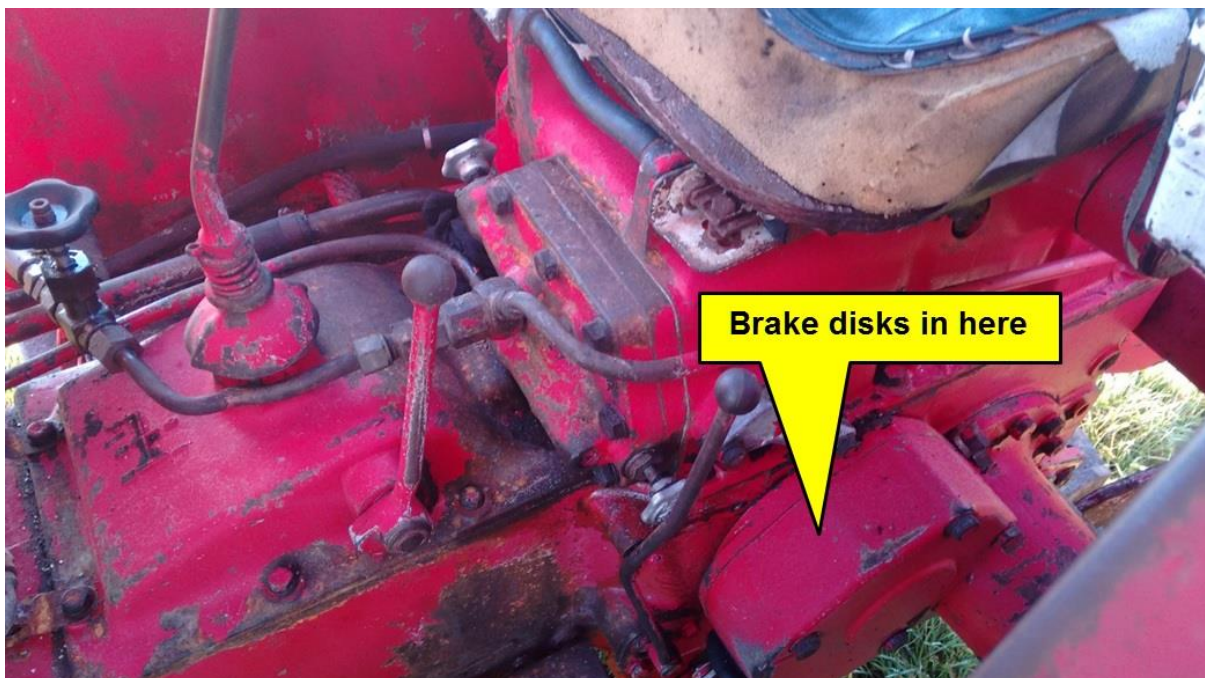
This tractor arrived with absolutely no braking, so the investigation started...

To begin, the cast cover shown above needs to be removed. The linkage between the brake pedal and brakes is different for the two sizes of brakes but disassembly is relatively obvious and explained in detail in the previous article.

Four bolts (five for the early brakes) hold each cover in place. When the cover was removed, everything fell apart in a sticky oily mess. 5 of the 6 springs holding the expanders together were broken. The rivets on the disks were so worn that one disk only had a single rivet still holding the friction material to the central metal plate and, as a consequence, the friction surfaces were badly scored.

So just about everything that could be wrong, was! To fix, it needed:

1. Relined brake disks
2. Replacement expanders & springs
3. Replacing the oil seals
4. Re-facing the casting friction faces.
5. New rubber sealing boots.

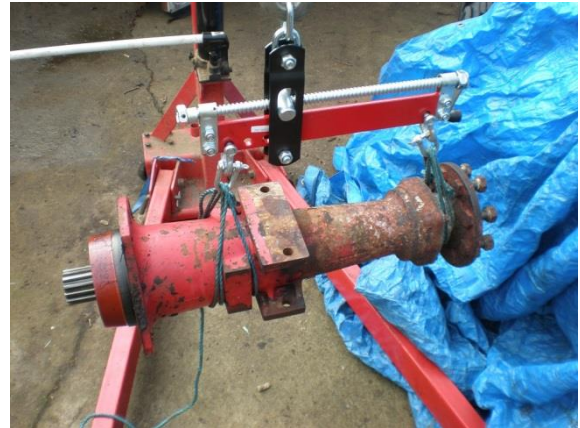
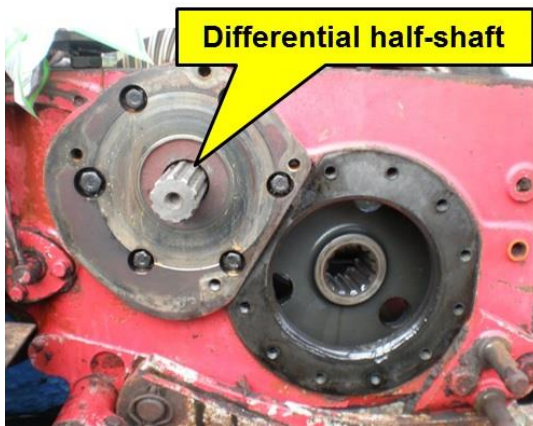
The photograph shows a view with the left axle removed and the differential half-shaft with the bearing housing around it. The bull gear is visible inside the hole left by the axle.

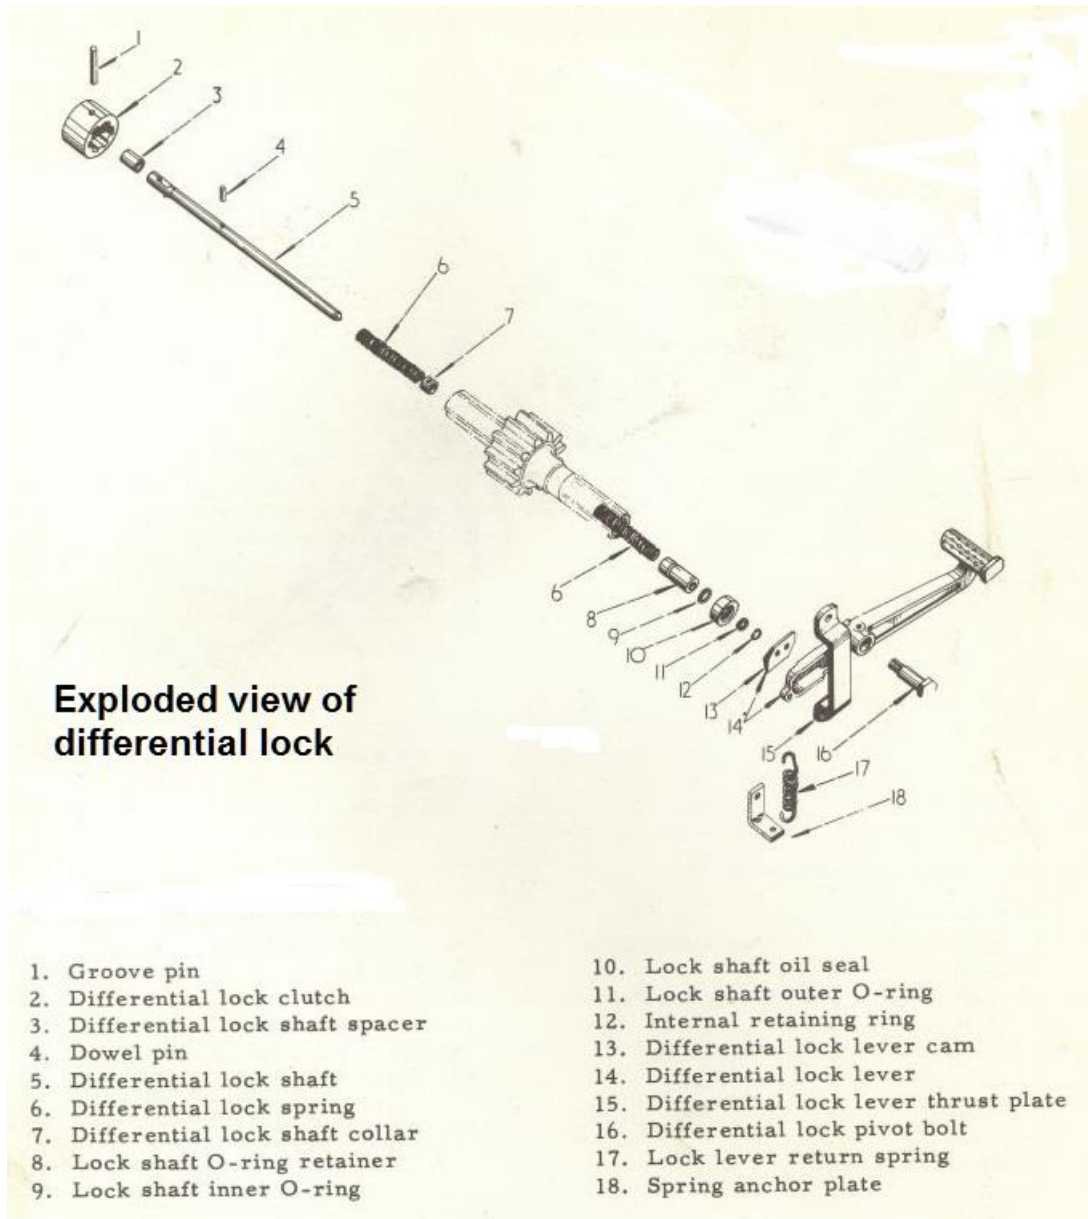
In the diagram above, items 1-5, the first spring 6 and item 7 are all retained within the differential assembly. The diagram doesn't make clear that the spacer (item 3) is pushed against item 1 by the first spring (item 6) which is held in place by the collar (item 7) which is retained by the dowel pin (item 4.) This grouping of components is held within the differential gear assembly.

Shaft 5 passes through the differential half-shaft (the gear not numbered in the diagram) with the second spring (item 6), O-ring retainer (item 8) fitted to the outboard side of the differential half-shaft. The spring and O-ring retainer are held in place by a fine wire clip (item 12) – **these three items need to be removed to allow the differential half-shaft (which is held between bearings in the bearing housing) to fully release from the differential.**

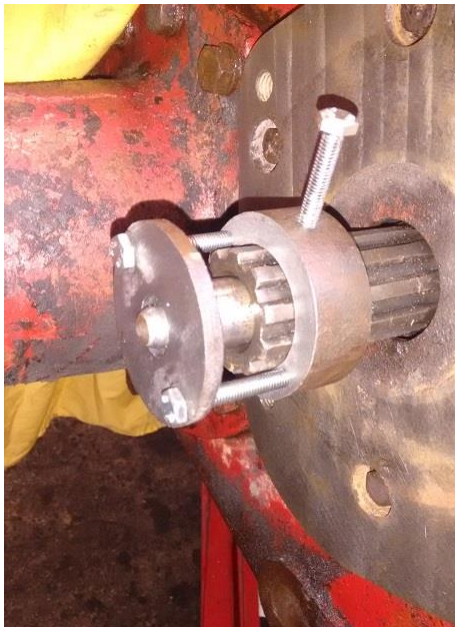
After doing this on a previous tractor, I made a compression tool to help both with the disassembly and reassembly of the O-ring retainer. The end disk is counter-bored to locate on the O-ring holder and is relatively thin in this area to make access to the retaining wire clip easier.

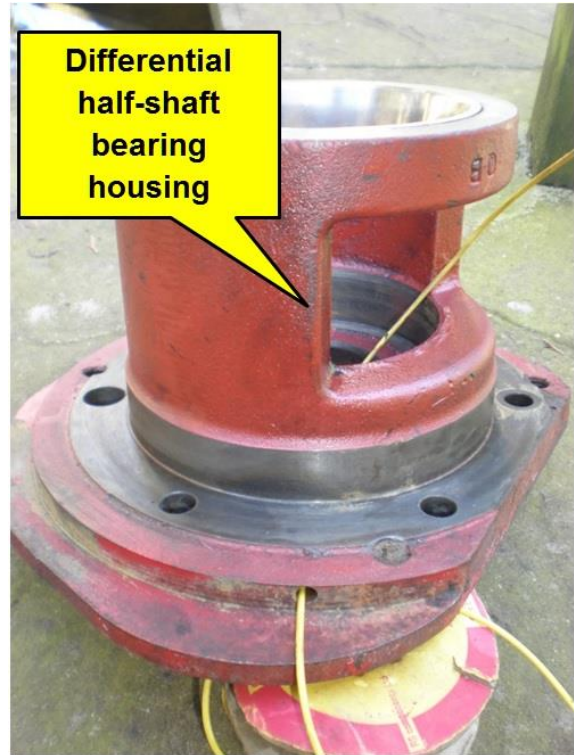
This photograph shows one of the differential half-shaft bearing housings – the face that it is sitting on is the brake friction surface and the large hole to the side is where the bull gear engages with the half-shaft pinion. The gap in the side is where the bull gear engages. The yellow wire indicates a hole intended to let oil from a leaking seal out rather than contaminate the brakes. On this tractor the hole on each side were blocked solid – had they been clear then there would at least have been some braking. Most owners don't know about these holes so they are filled with dirt and can't do their job.

It is a sensible preventive maintenance task to identify these holes and ensure that they are clear, even if your tractor doesn't require such extensive repairs.

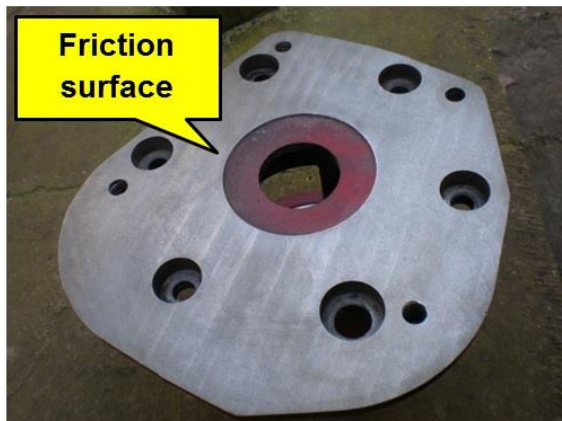
This photograph shows the friction face of the casting after machining – back to “as new” out of the factory. It needed about 60 thou removing but clearances are such that this was ok.

The differential half-shafts were pressed out of their bearings, the casting front face machined flat in the mill and, eventually, the oil seal replaced.
