Why Did These Cylinder Head Gaskets Fail?

Anglo Agriparts Tech Bulletin 'Head Gasket Failure' – For the full series visit: www.anglo-agriparts.com

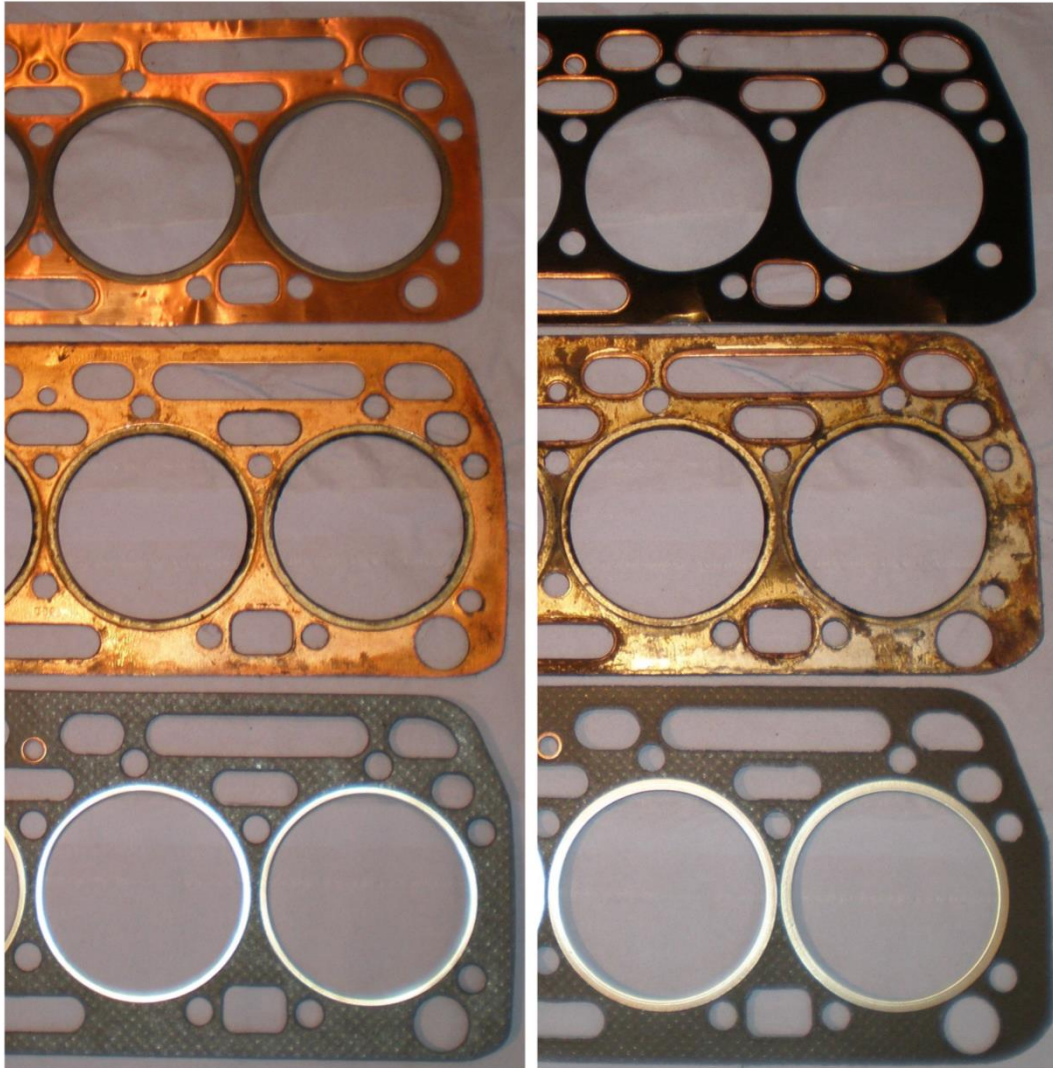
The two old gaskets plus two different types of replacement were all examined. Three head gaskets are shown in the following image. From top to bottom they are

1. New gasket, solid copper top face, steel rear face, damaged in transit buy cylinder liners bouncing on it. Unlike the other two gaskets there was only a narrow raised steel lip, formed from the back steel sheet, as the liner seal.
2. Used gasket as fitted to both tractors, again with solid copper top face and rear steel face. One of these was fitted with rubber sealing washers in the water jacket circular holes – neither showed signs of leak in this area.
3. New gasket (copper saving apparently) with steel core and gasket material for both top and bottom faces but steel reinforcing for the liner seals and copper seal for the rocker shaft oil feed.

There were no obvious reasons found to indicate that any of the three types had any design or manufacturing defects so suspicion has to fall on poor assembly.

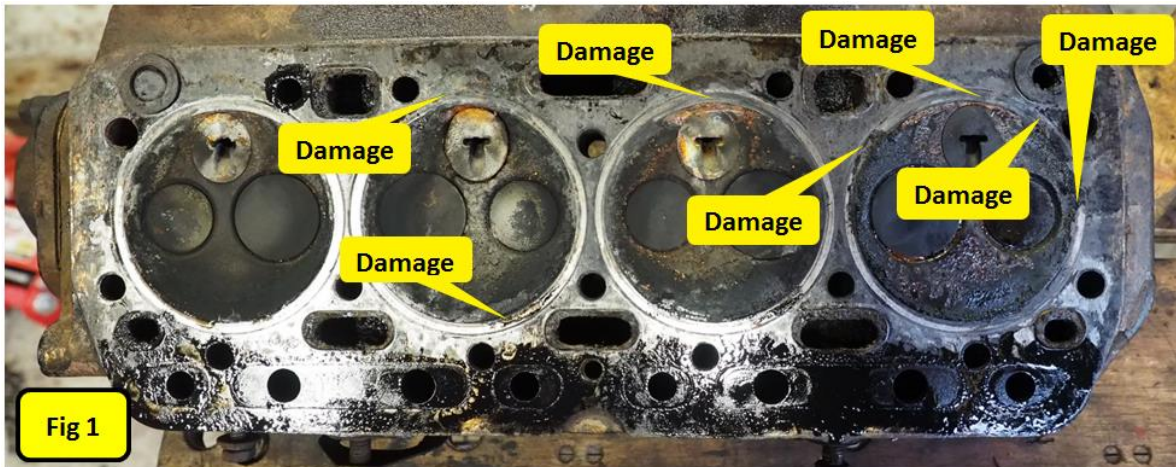
Both tractors had exactly the same make and model of head gasket and while the B275 looked ok, the B414 (Fig 1) was a mess. Despite having the same gasket, the B414 had two rubber washers (visible at the top of the cylinder head) sealing holes for the water jacket but neither showed signs of leaks in this area.

The first impression was the amount of oil on the top side of the gasket and cylinder head face. The lower side of the head gasket and top of the block were clean so the problem was between head and gasket. Closer inspection showed that all four pre-combustion chambers were cracked and that the gasket had been leaking in at least three places with leaks between cylinders, and cylinder to rocker shaft oil feed and cylinder to water jacket. Just some of the damage is highlighted in Fig 1.

The underside of the head gasket around the rocker shaft oil feed hole, which is normally raised above the surrounding gasket (to give a higher pressure seal), was crushed flat with the surrounding gasket, unlike the same gasket from the B275. This possibly explained the oil leak... or the bolts may even have been over tightened in an attempt to stop an initial oil leak.

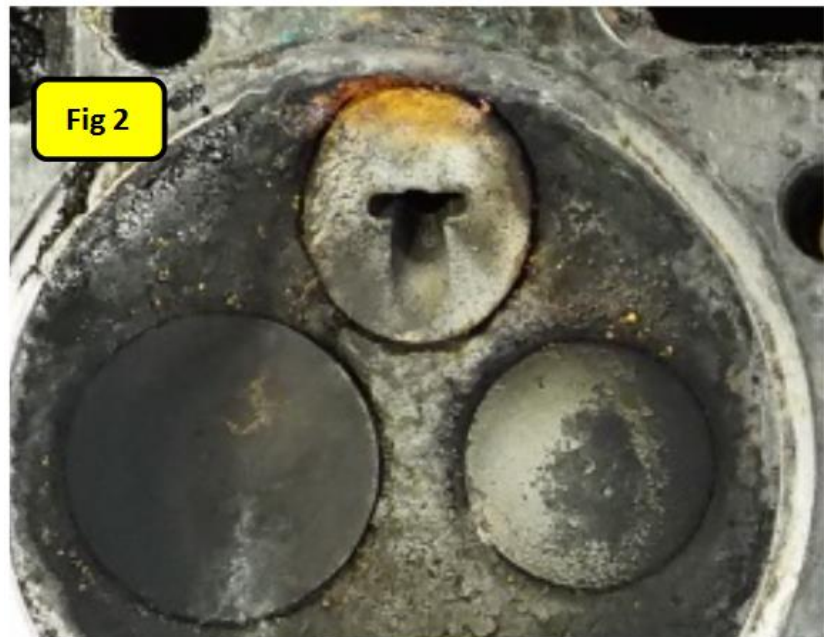
Fig 2 shows corrosion at the top above the pre-combustion chamber where combustion gasses have been leaking and water entering.

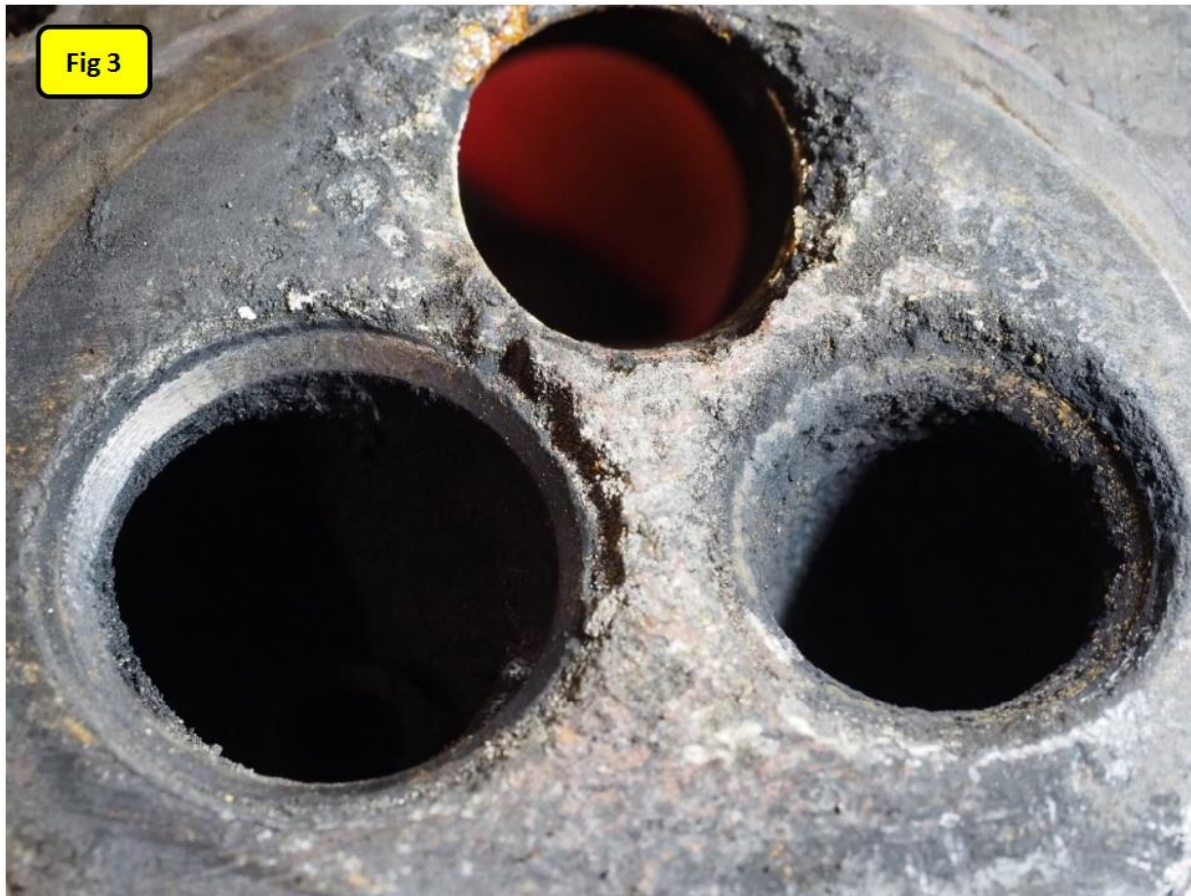
Fig 3 shows the worst part of the cylinder head where there had been the leak. The head was badly eroded around both valves (especially intake) and around the pre-combustion chamber. The other three cylinders showed less severe damage but also gave the impression that water was passing via the open inlet valve on the faulty cylinder into the inlet manifold and then into the other cylinders.

This head had been removed with a torque wrench to see how close the bolts were to recommended torques. Approximately half of the bolts were around the correct 75 to 80 ft lbs but the remainder were all over the place – some loose and some over tight.

The cylinder head face however is another matter. Any pitting, radial surface scratches or other damage where the head gasket steel faces meet creates a weakness that could lead to failure so this is an area that should always get special attention when preparing the cylinder head. As the B414 didn't get a cylinder head overall, possibly the gasket sealing face condition was also ignored or given minimal attention.

To ensure the best chance of a good seal, finish the cylinder head face with wet-and-dry paper lubricated with thin oil, diesel, white spirit or paraffin. End up with 240 or finer grit, backed with a flat plate or board. One is looking for a satin finish with NO defects where the still ring will fit.

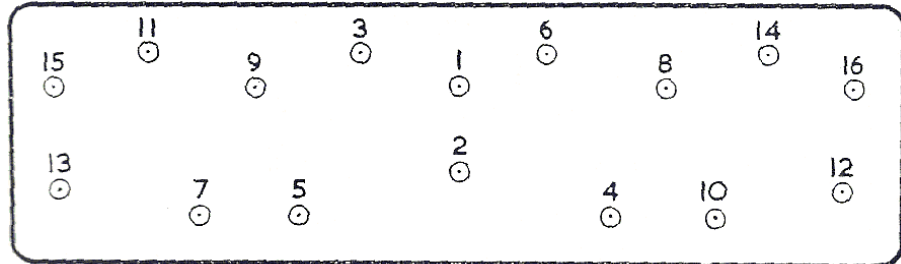
The cylinder head is held in place by 16 bolts, 15 shorter ones and a longer bolt that passes through the middle rocker shaft retaining bracket.

From the workshop manual the tightening order is as in this diagram (front of engine to the left) with number 1 being the long bolt.

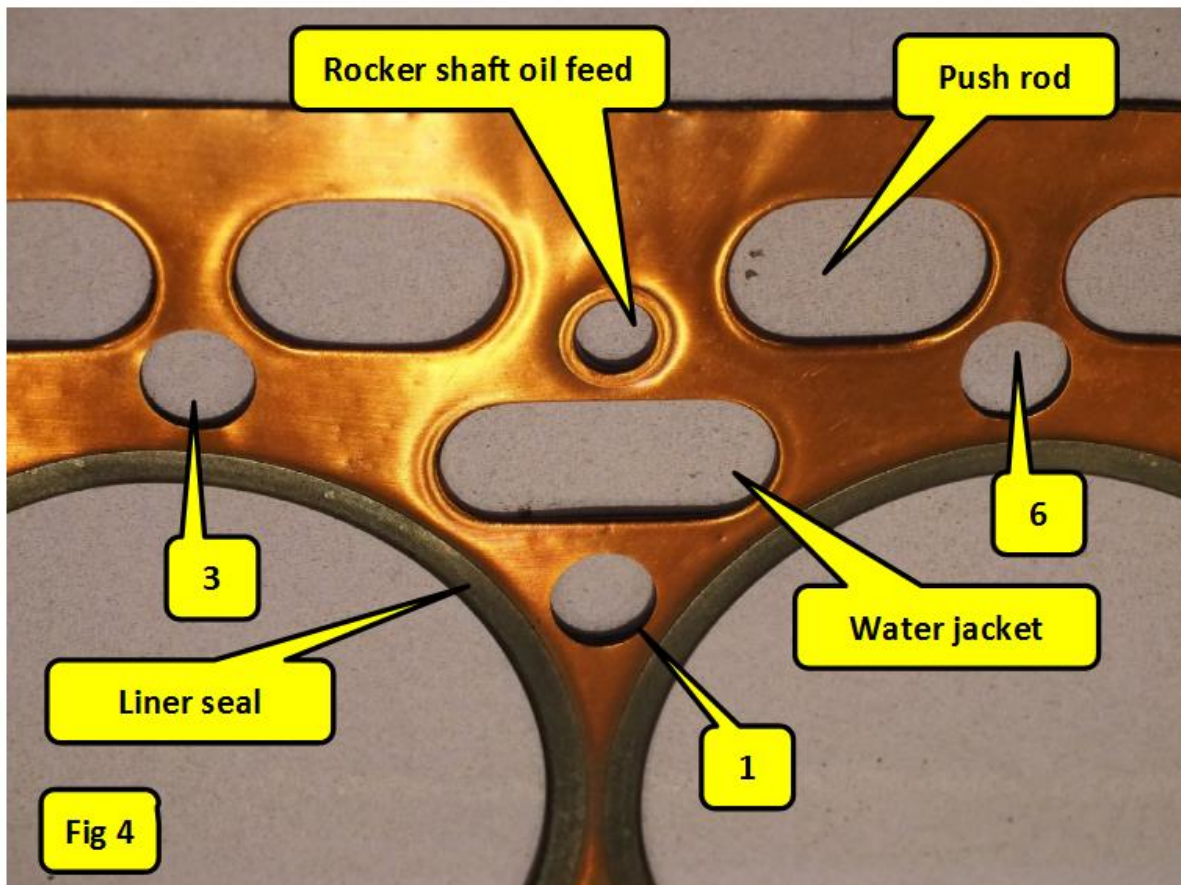
This photograph is of a new gasket that couldn't be used due to damage in transit when it was packed with the new liners for the B275 but no consideration of what would happen when the liners bounced on it! It is however helpful in identifying where the problem areas are.

The top four oval holes at the top are for the push rods. The numbered holes correspond to the cylinder head bolt numbers in the previous diagram. The water jacket hole obviously is one of the paths that water flows between engine block and cylinder head. On this style of gasket (and there are several different designs in use) the top copper face is rolled over on the reverse side (like the

rocker shaft oil feed on the top surface) to provide a raised lip to increase the pressure at the point of sealing.

The liners come in for special treatment in that they have an additional pressed steel reinforcing ring (it looks the same on both sides.) Correctly installed liners should have their top face between 1 and 5 thou higher than the engine block to ensure that there is greatest clamping force around this steel ring. This seal therefore relies on steel to steel (liners) and steel to cast iron (cylinder head) joints and is subject to the highest sealing pressures and temperatures anywhere in the engine excluding the valves in their seats. When rebuilding an engine the liners, being turned parts, only have fine machining marks tangentially to the bore (i.e. in circles round the bore) on the gasket mating face and so provide a very good sealing surface... which probably explains why there were no signs of leakage in this area on either tractor.
