Anglo Agriparts Tech Bulletin 'Fault Finding On A Dynamo' - For the full series visit: www.anglo-agriparts.com

Dynamo Internal Fault-finding

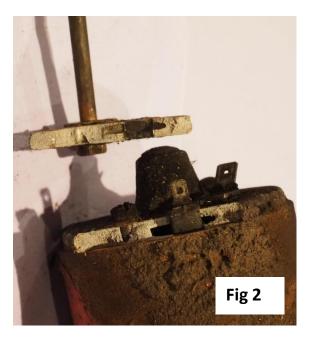
various inclusions leading to weak spots. Over time and due to corrosion the casting could grow onto fixing bolts making the dynamo difficult to remove.

This photograph shows a broken end casting from a different dynamo. The long top mounting bolt had seized into the casting and a quite light tap broke the casting into two. The fracture line is very thin in places and, not clear in the photograph, there were small inclusions in the fracture line.

So, **DON'T TRY TO KNOCK OUT THE TOP BOLT**. If the bolt is tight then it is probably best to remove the dynamo with bracket so the bolt can be carefully removed on the bench.

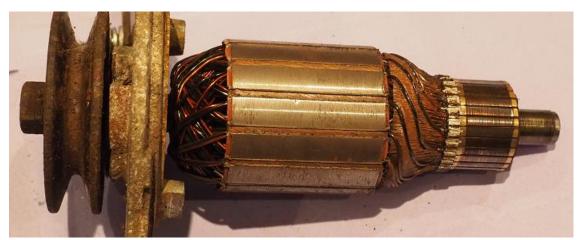
- The resistance was measured between adjacent armature segments looking for any significant difference in readings a disconnected or shorted winding would be expected to give a difference of 40% or more from the normal readings. Again everything looked ok. Using the multimeter shown earlier, a typical reading on this armature was about 0.6 or 0.7 ohms the accuracy of reading is poor but good enough to show if one or more windings are disconnected (higher than normal reading) or shorted (lower than normal reading.) If a wire is disconnected then re-soldering it at the commutator may be all that is necessary. A short, unless there is an obvious solder bridge between adjacent commutator segments, most likely needs a replacement armature with a replacement dynamo likely to be the lowest cost solution.
