Bradford Built International Harvester Major Brake Overhaul

While there are several descriptions around on how to change the brake disks on the Bradford built International Harvester tractors, a full restoration is a quite different and major task.

The following description is primarily for the later brakes as on this '67 B434 but applies equally to any tractor fitted with the later brakes. Operations on the earlier brakes are very similar and subsequent notes will highlight any differences.

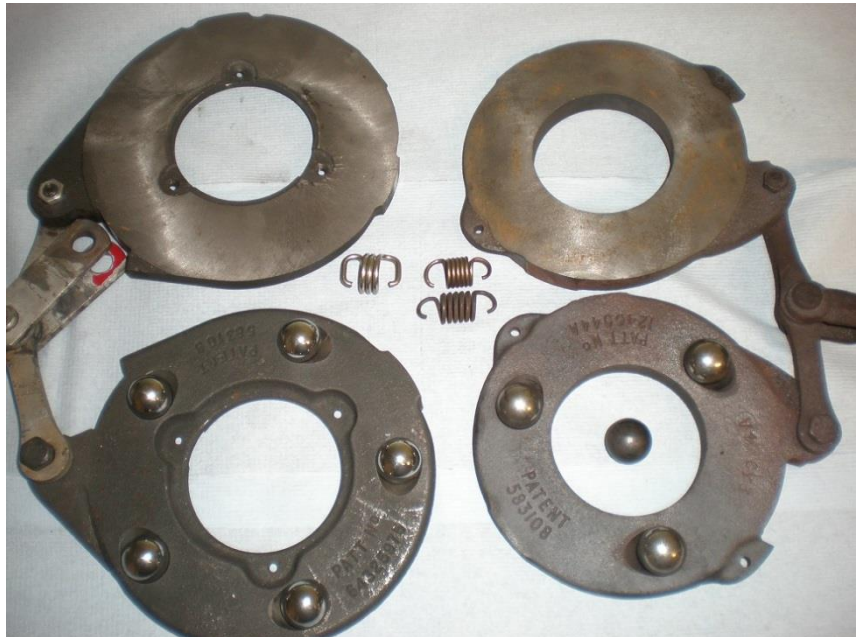
New expanders were obtained from Anglo Agriparts. These were good quality and well protected with grease and paint, but needed to be prepared before use. The paint on the outer friction faces was removed with a wire brush on an angle grinder then everything degreased. These expanders are normally installed dry with no grease on the ball bearings or inner surfaces.

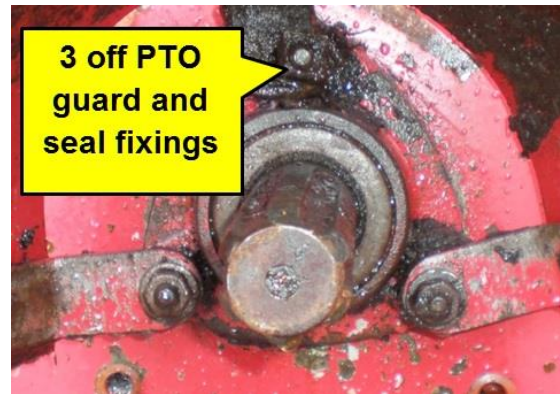
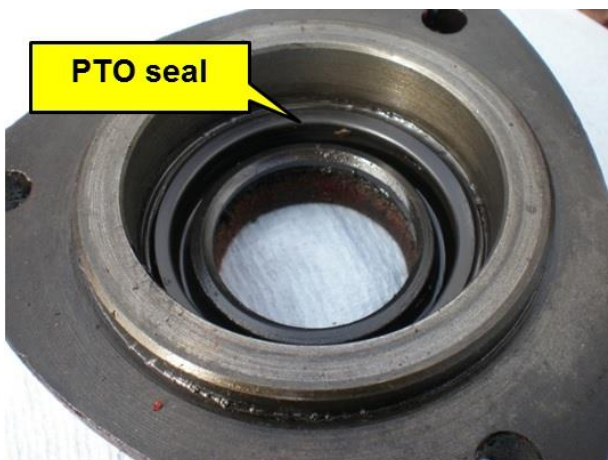
The PTO shaft pulls out the back after 3 bolts (or nuts on some tractors), which hold on both the PTO guard and seal housing, are removed.

With the PTO seal housing out, it was also a good time to replace the seal.

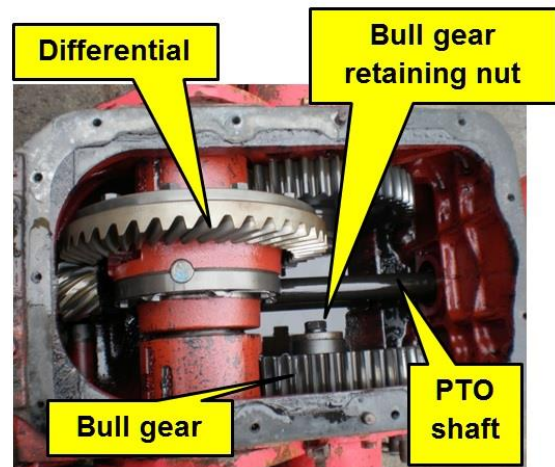
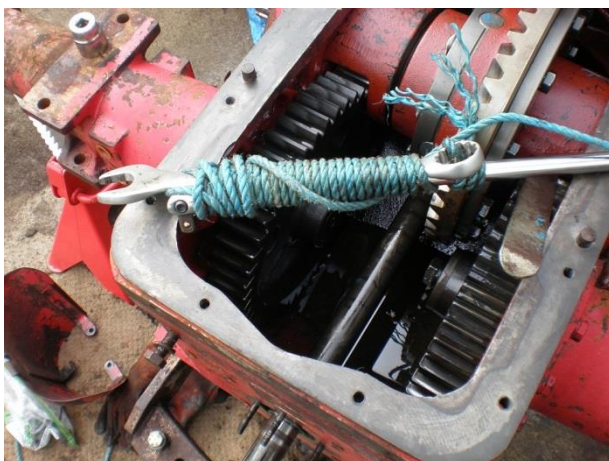
The thin walled socket used gave way (now replaced with a 6-point stronger version) but, as a short term solution it was Heath Robinson to the fore.

This method of extending an open ended spanner (3 foot wrecking bar) can be surprisingly effective at times, provided that the spanner is of good quality.

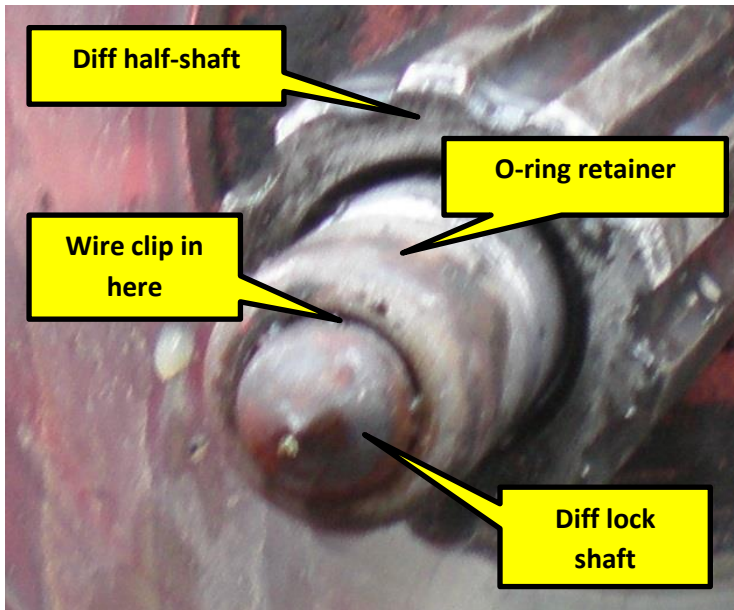
The wire retaining clip (item 12) is exposed by pushing in the O-ring retainer along the diff lock shaft... but there are complications. As the retainer is pushed in (e.g. with a screwdriver), the outer spring (item 6) compresses and the shaft also moves in unless it hits a stop of some form. The only stop available is the diff lock clutch (item 2) which normally catches on the end of the left diff half-shaft... but it is possible for the clutch to engage and the O-ring retainer will not move on the shaft. If this happens, rotate one

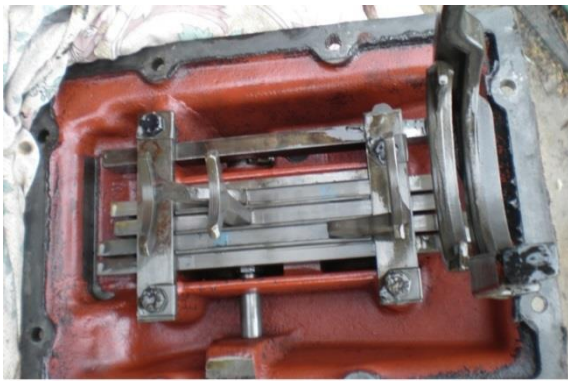
It can be helpful to select neutral and high ratio then photograph the position of the selectors as seen in this photograph of the underside of the cover.

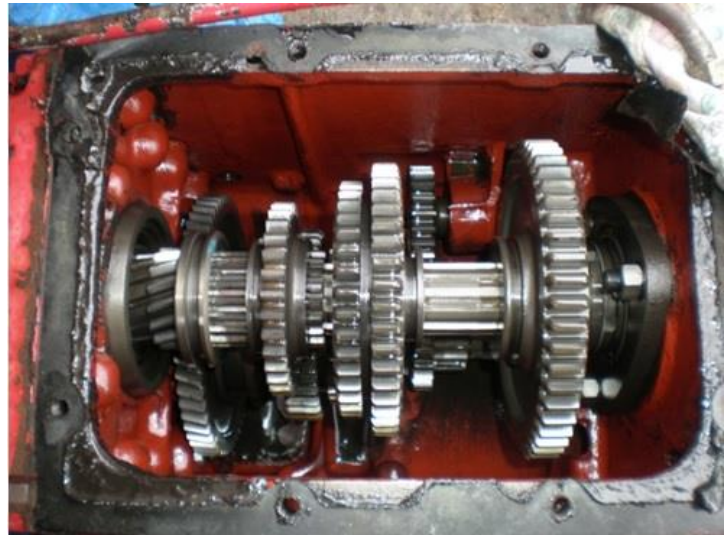
Another useful photograph is of the internals of the gearbox to record the position of the gears for when the cover is replaced – they all need to be aligned correctly with the selectors or things will not work as expected.

Fortunately, all the gears and selectors seemed to be in very good condition.
